COMMONWEALTH OF KENTUCKY
BEFORE THE PUBLIC SERVICE COMMISSION

WESTERN KENTUCKY GAS)	
)	
_____)	CASE NO. 97-289
)	
ALLEGED VIOLATIONS OF 807 KAR)	
5:022)

O R D E R

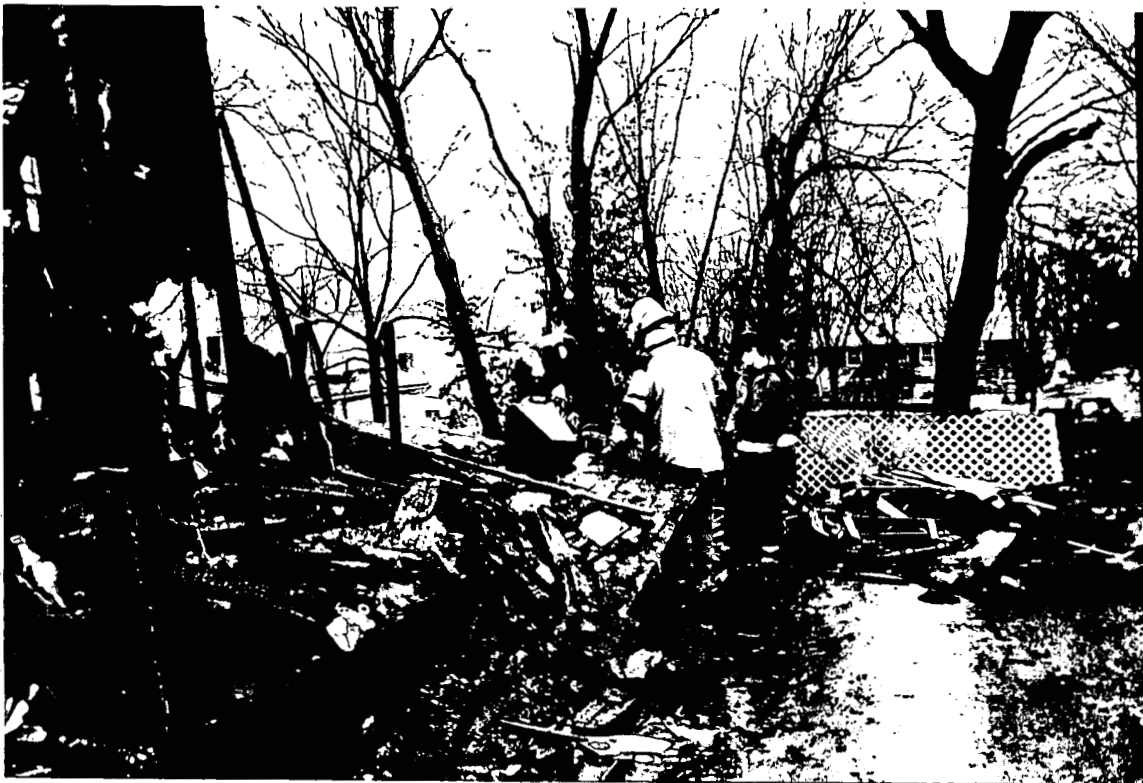
PHOTOGRAPH 5 - Fire department representative sawing opening in floor. Taken looking north from northeast corner of drive between 511 & 509 Smith Street (3/5/97).

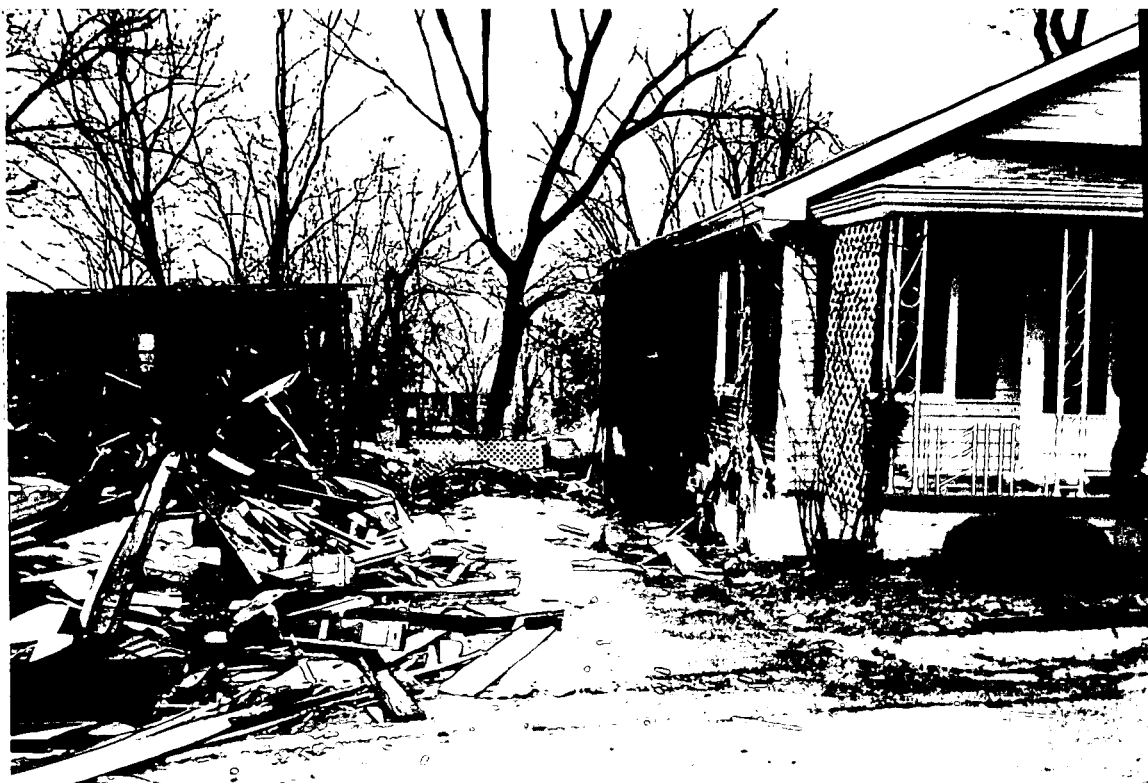
igniting when the wall blew out and fell on the gas meter, regulator, and piping (Attachment 1, Photograph 7). The house at 509 Smith Street suffered severe fire damage (Attachment 1, Photographs 1 & 2) as well as two automobiles in driveways on both sides of the house. The house on the west side suffered debris damage (Attachment 1, Photograph 4).

PHOTOGRAPH 1 - Front and east side of house. Debris covering area of curb valve location. West side of 509 Smith Street also shown. (3/5/97)

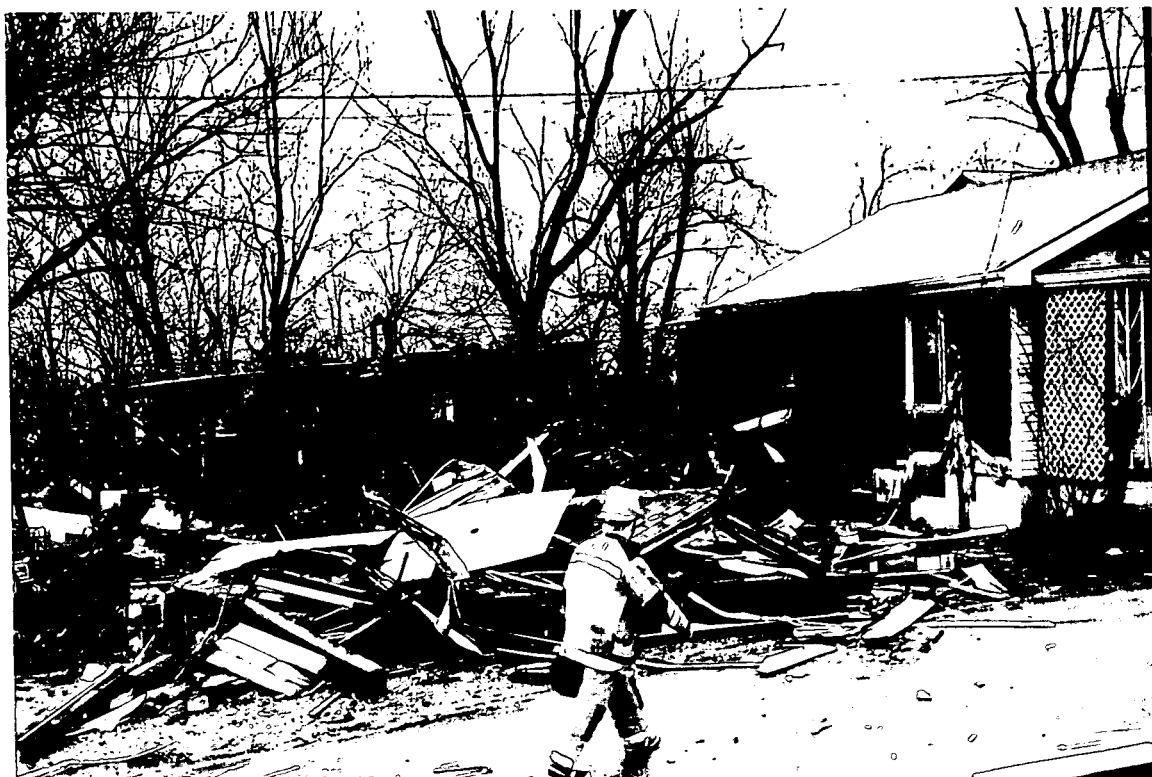
PHOTOGRAPH 2 - Front of house and west side of 509 Smith Street also shown. (3/5/97).

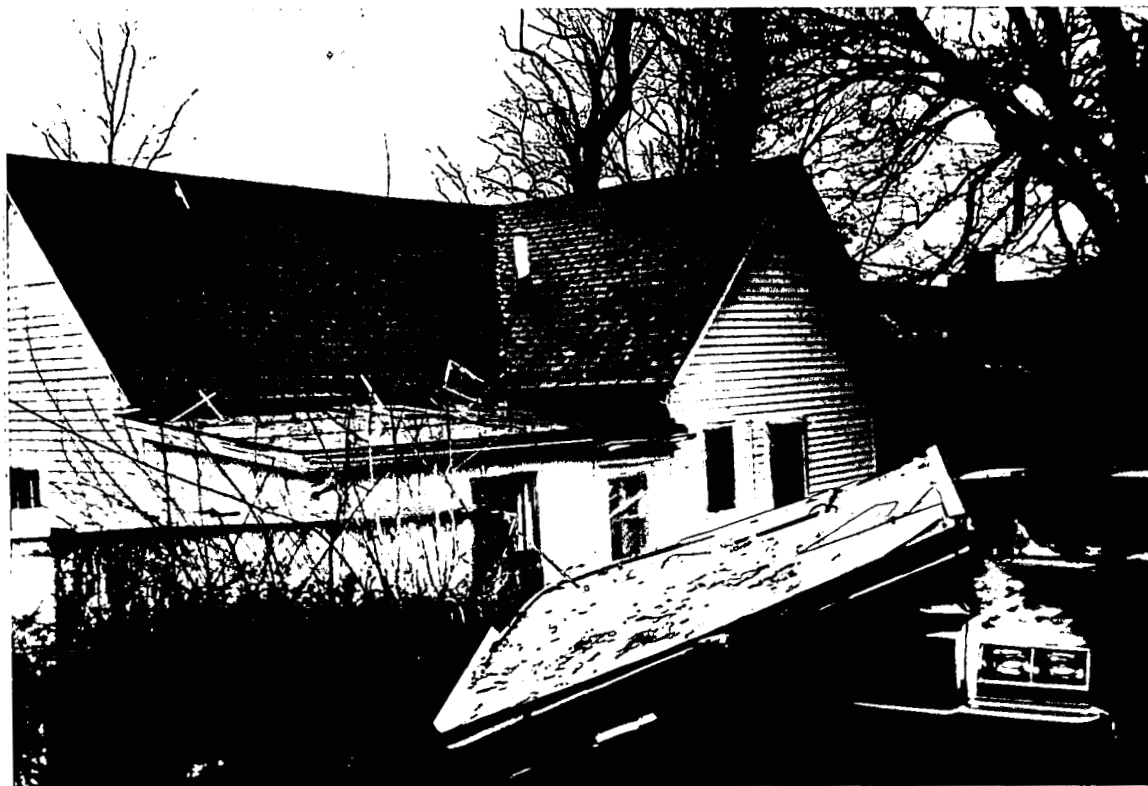
PHOTOGRAPH 4 - Portion of wall of house looking northwest from front. Also shown is east side of 402 6th Street with debris and explosion damage. (3/5/97).

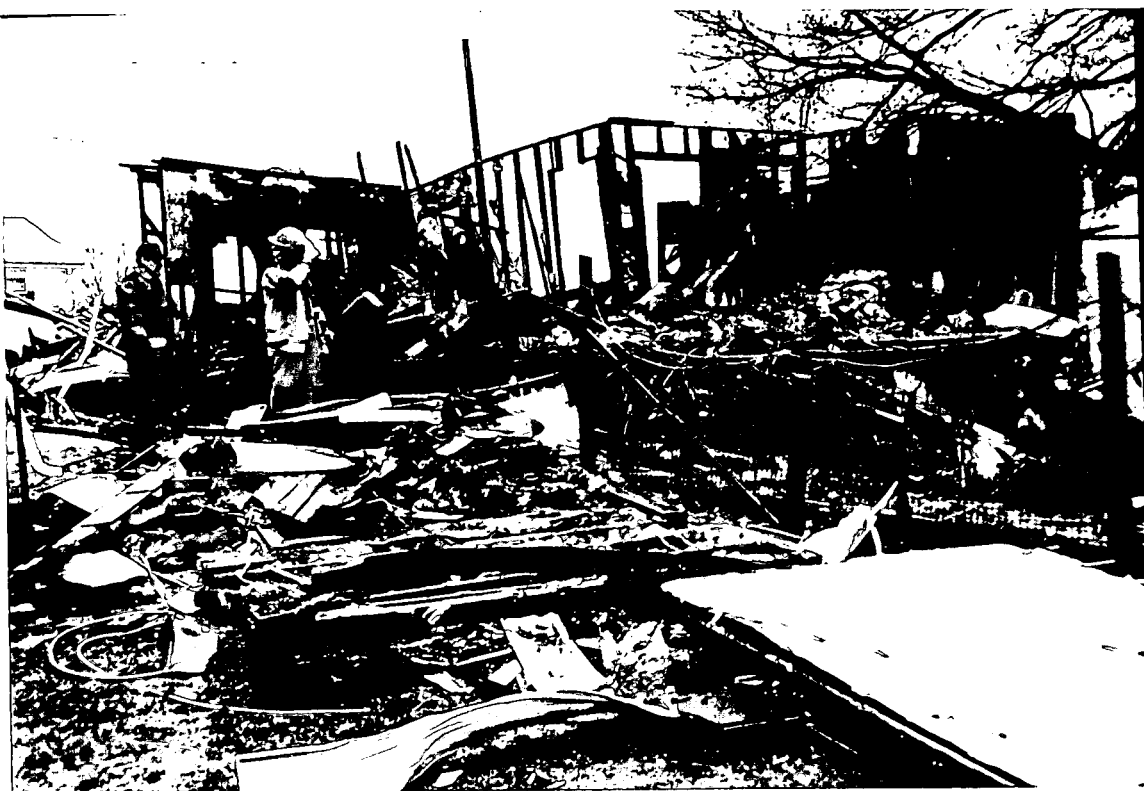
PHOTOGRAPH 6 - Fire department representative sawing opening in floor to provide access to basement. Photograph taken looking south from rear of house. (3/5/97).

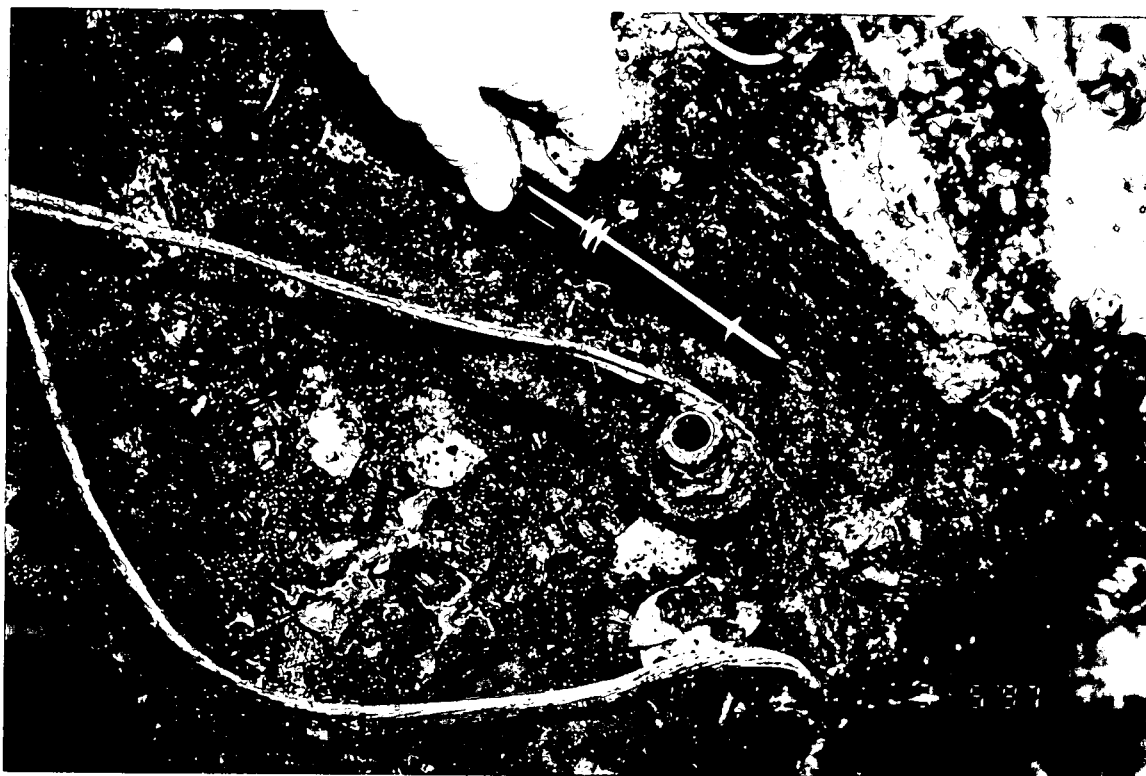
PHOTOGRAPH 18W - 1/2-inch gas line behind range showing 1/2-inch bronze range connector. (3/5/97).

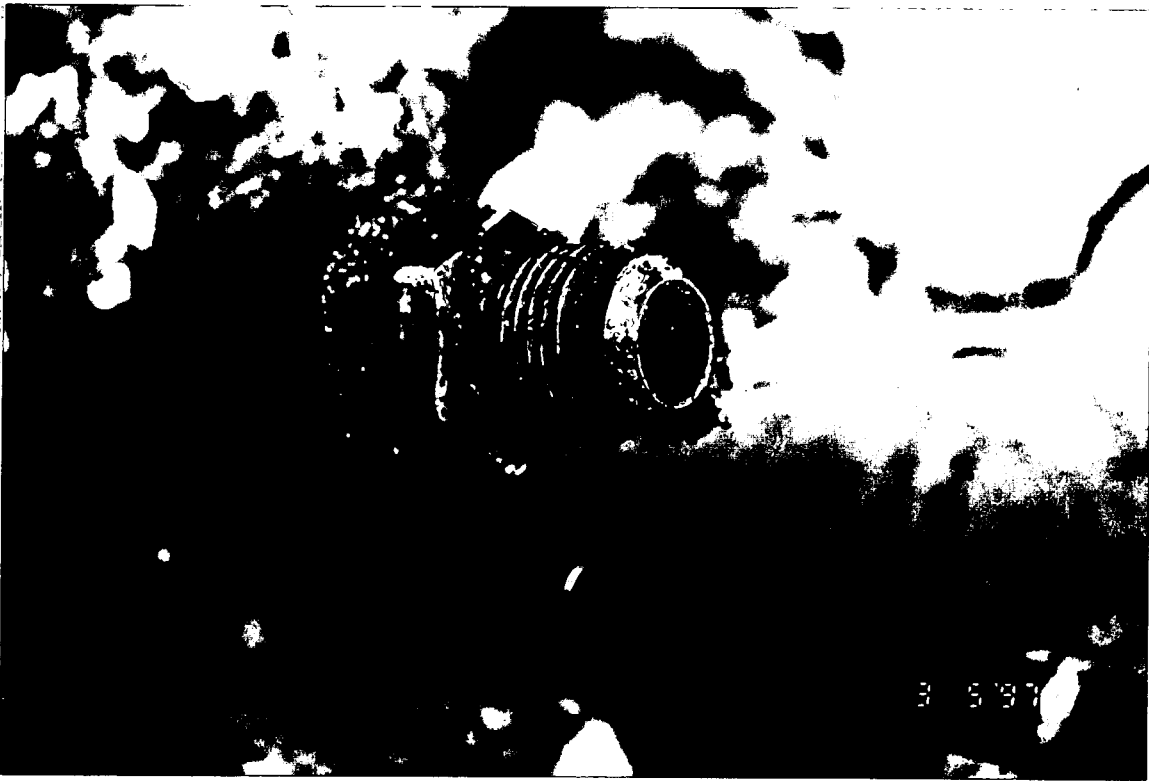
PHOTOGRAPH 19W - Same as 18W. Closeup of range connector. (3/5/97).

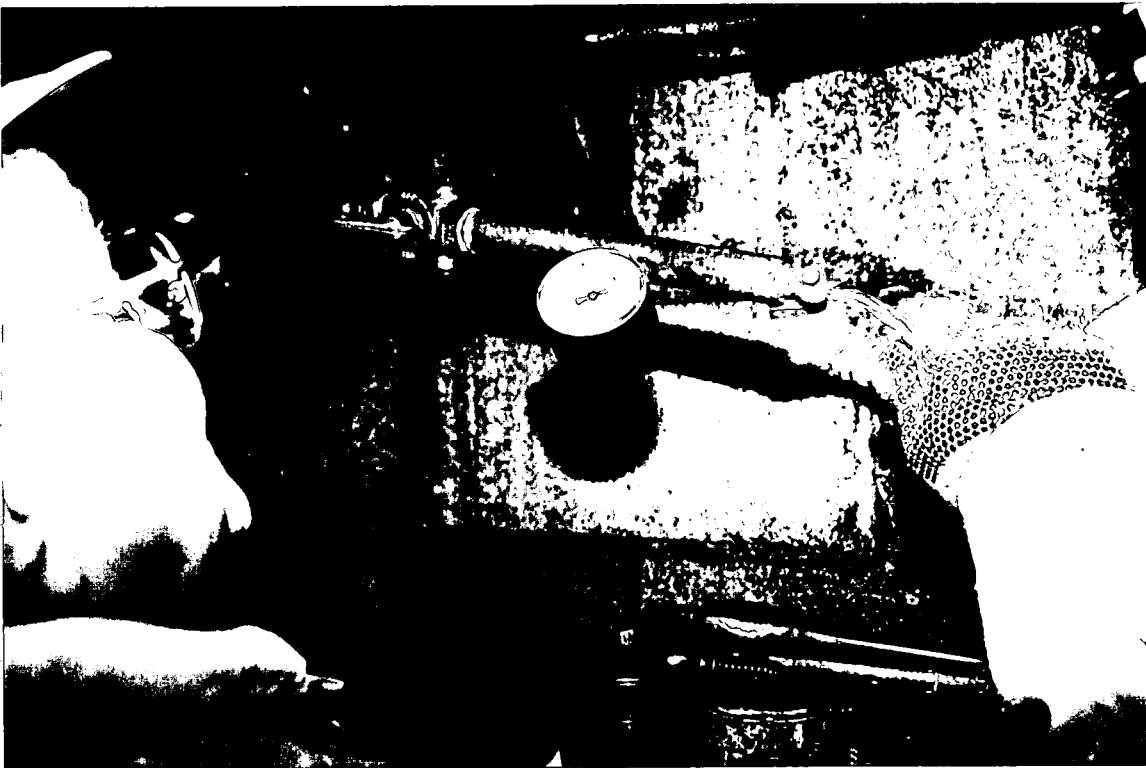
PHOTOGRAPH 15W - Test gage and hand ball pump connected to 1/2-inch brass valve pumped by Mr. Teter. (3/5/97).
